# Documentation on Dam Leakage, Breaching and Disaster Management at Karam Dam, Madhya Pradesh

**National Institute of Disaster Management**

Ministry of Home Affairs, Government of India

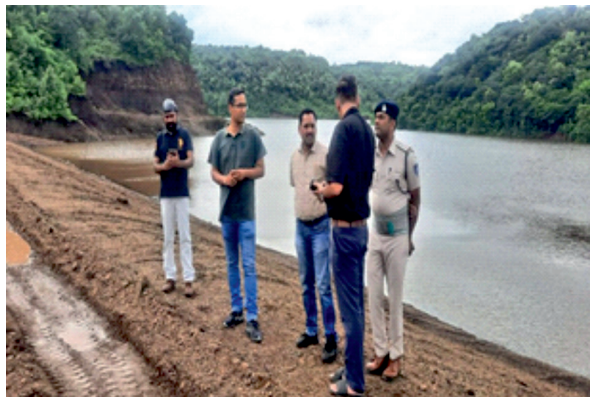
Around 2:15 PM on 11<sup>th</sup> August 2022, the villagers near the Karam dam site noticed the piping from the bund, and the same was informed to the district authority through a video record of the piping in the dam. Immediately, after receiving the information District Magistrate and Superintendent of Police of Dhar district were alerted and rushed to the dam site to analyze the severity of the situation (Fig. 2-1). The technical teams (WRD, Project management) and administrative teams (DM, ADM, SDM, SP, and others) gathered at the site quickly to assess the situation. The initial assessment of habitations downstream as a precautionary measure was made.

*Figure 2-1 : Inspection of leakage Dam site being done by District Magistrate, Dhar and Superintendent of Police, Dhar, ADM Dhar & Dam Engineers*

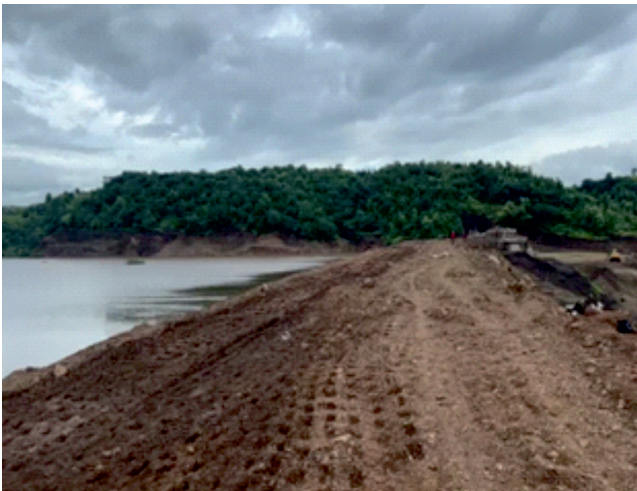
Figure 2-2 : Roller compaction of Embankment crest

The WRD engineers initially surveyed the structure and started working on leakage repair by roller compaction on top of the embankment (Fig. 2-2). The seepage is controlled to an extent. However, the downstream habitations were alerted about the likelihood of dam failure. An official of Executive Magistrate rank was deployed on-site for the precautionary measures. The initial analysis found that the dam was not constructed as per the design as shown in Figure 2-3. Some of the probable causes for the failure of under constructed Karam dam are discussed below:

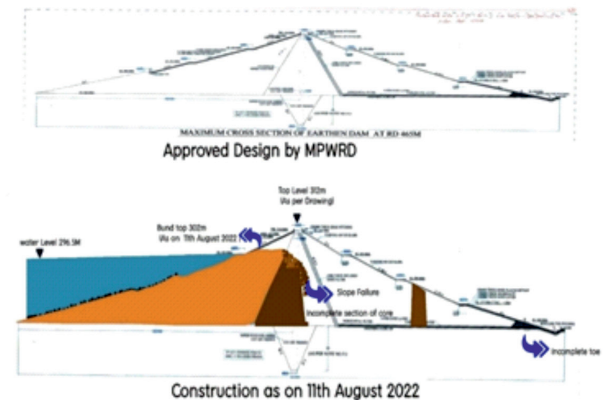
Figure 2-3 : Status of dam construction as on 11<sup>th</sup> august 2022

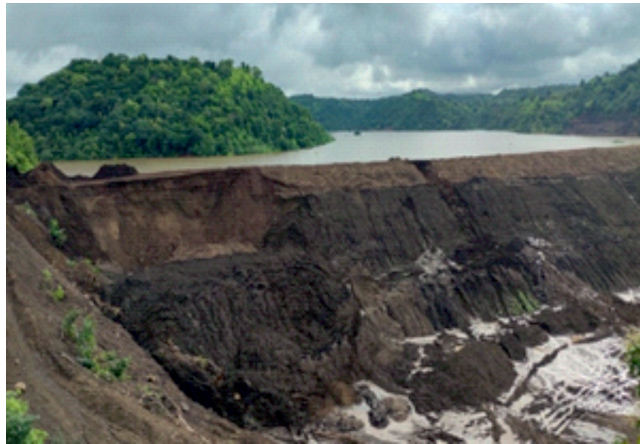
*Figure 2-4 : Slacking of soil from the embankment*

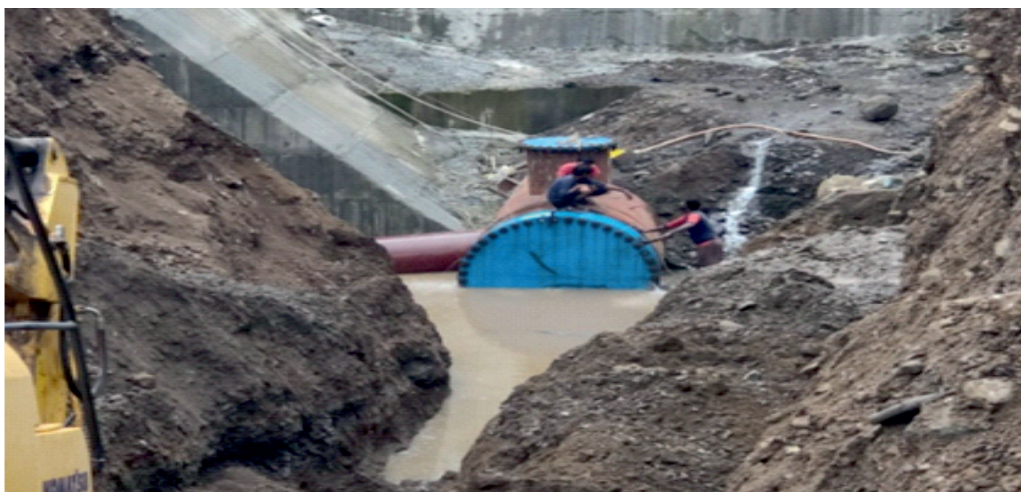
*Figure 2-6 : Efforts to open the Sluice gate which was closed*

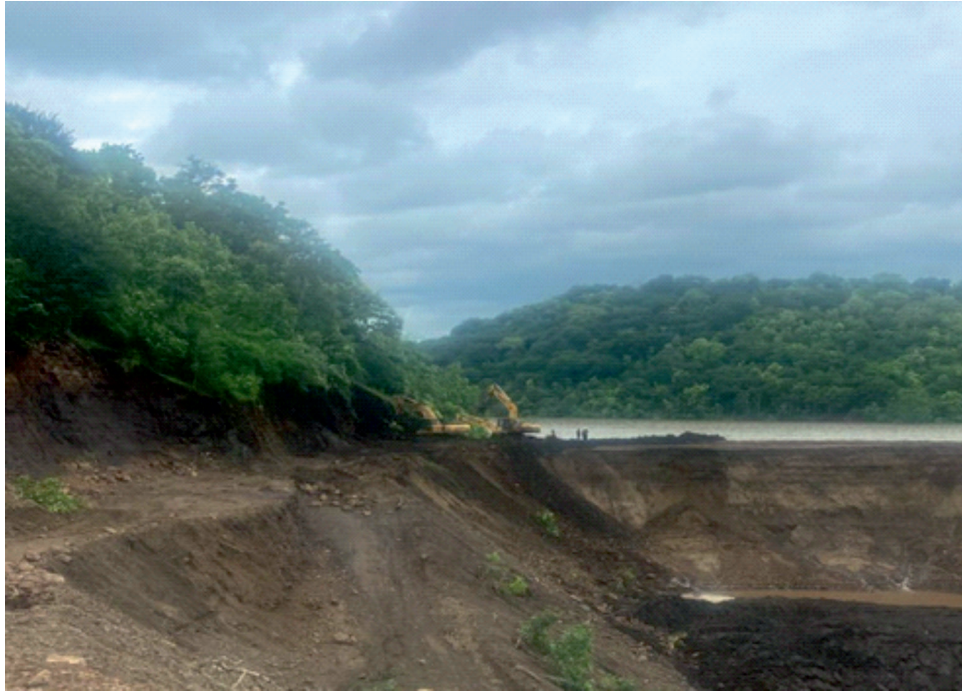
*Figure 2-9 : Excavation for bypass channel*

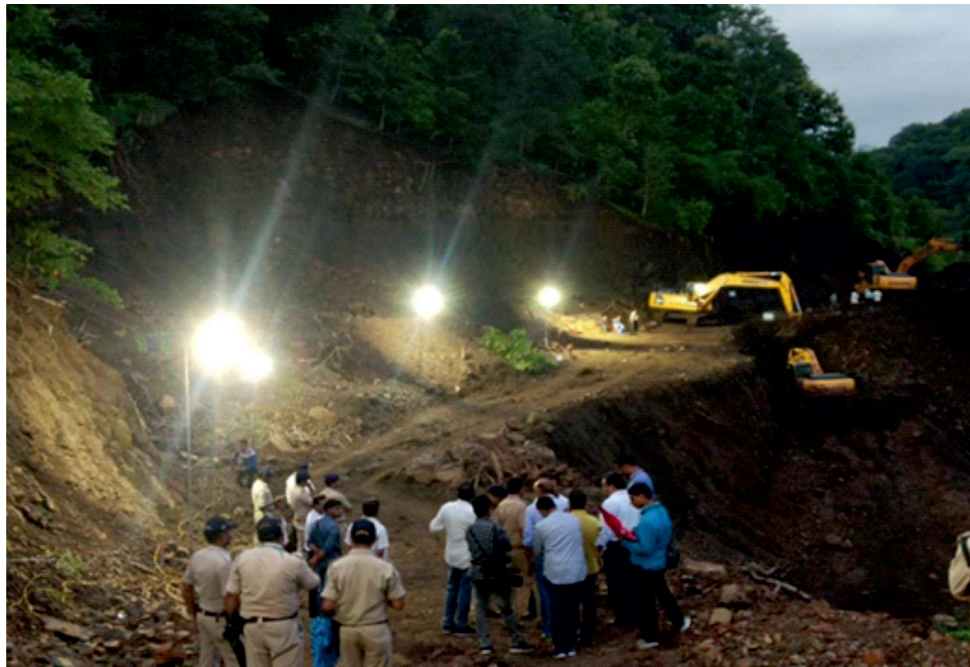
While making the channel on the right flank a hard & big stone encountered by the machines faced difficulties in achieving the required depth of the channel (Fig. 2-10). The administration and technical teams were not sure about the extent and exact nature of the flood because of cutting/controlled cutting which was taking longer time than expected. At the same time, the administration was also aware that the dam could breach at any moment because of the seepage which can cause a flash flood with an uncontrolled flow of water from the dam. As a result, the entire population/ villages (to be affected) were shifted to safe locations and SHGs were roped in for making food arrangements at relief camps. The district administration made sure that all domestic animals were also moved away to safe places. There was a total of 23 relief camps in both districts which were established to accommodate the population. The alert warnings of dam breaches were placed in the villages (Fig. 2-11).

Figure 2-10 : Excavation on right flank to make a channel

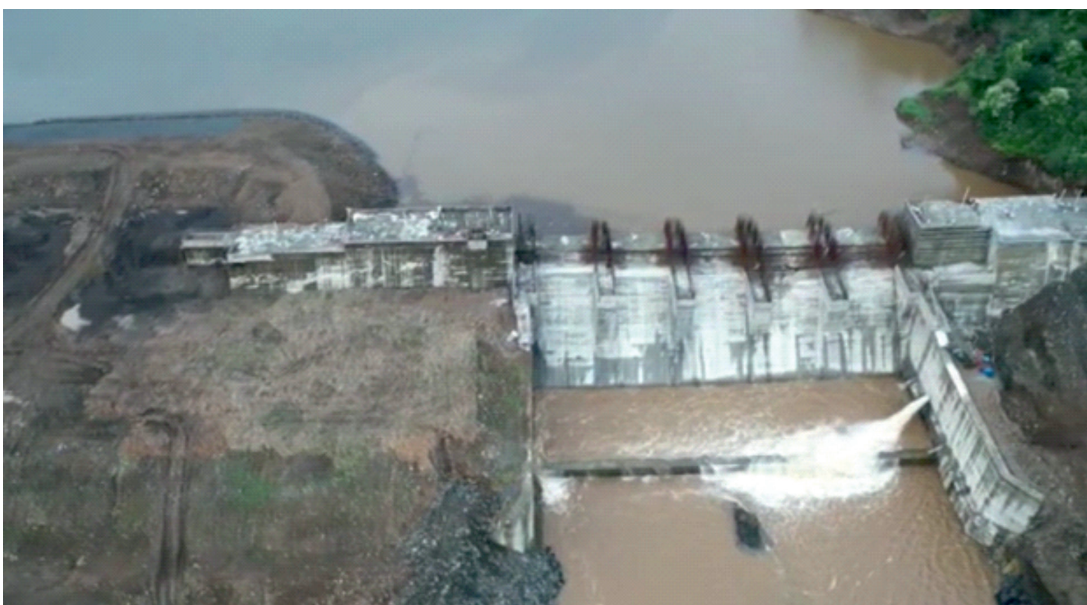
At 3:00 PM team on the west flank was able to finally open the sluice valve completely by breaking off the cover with the help of an excavator (Fig. 2-24). The capacity of the sluice valve to release the water was very low, i.e. 5 cumecs only. Technical teams were still working on the hard rock in the narrow channel till 4:00 PM. The team was working at the opening point and the stone breaker/ cutter was working on the same rock for the last 18 hours.

*Figure 2-24 : Discharge of water through a sluice valve*

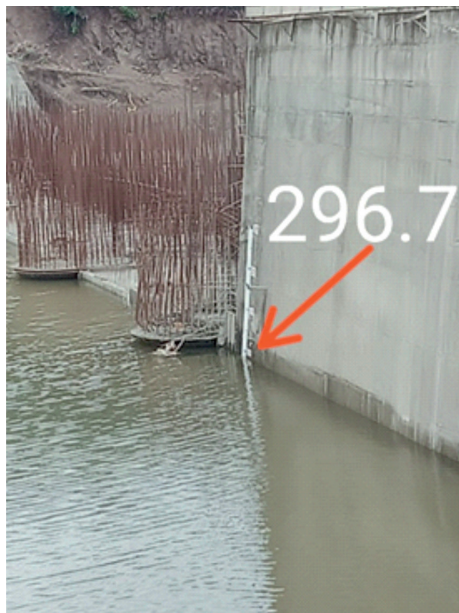
Though there was the discharge of water through the channel and sluice valve for the whole night, the water level instead of decreasing had increased to 296.7 m from 296.45 m due to the rainfall in the upper catchment area (Fig. 2-27). At midnight, the depth and width of the bypass channel were about 1 meter. Due to the rise in the water level, the team discussed on the decision of increasing the depth and width of the bypass channel to increase the discharge (Fig. 2-28) of water. At 10:55 AM the water flow had increased in the channel since midnight giving hope.

Figure 2-27 : Water level status at dam

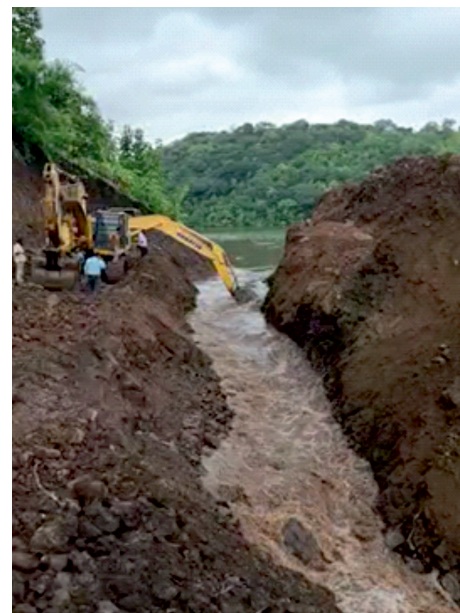
Figure 2-28 : Deepening status of channel  
at 12.00 noon

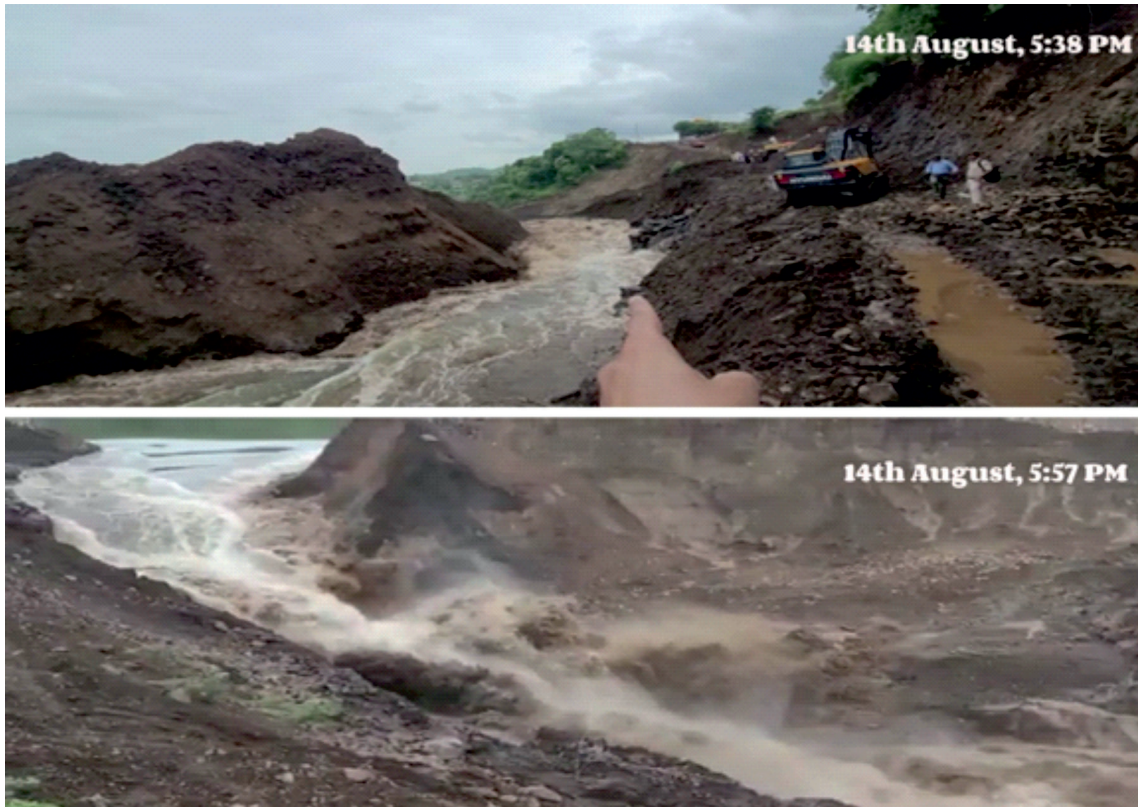
The excavation was continued with the aim to deplete the reservoir. But the hard rock restricted the efforts to obtain the desired depth of the channel. However, this hard rock acted as a boon in disguise as it diverted the water flow in the channel towards the embankment and increase the speed of cutting the embankment. So, the machinery was withdrawn from the excavation and water started playing its own role by cutting the edges of the dam (Fig. 2-29).

*Figure 2-29 : The breach in the dam embankment*

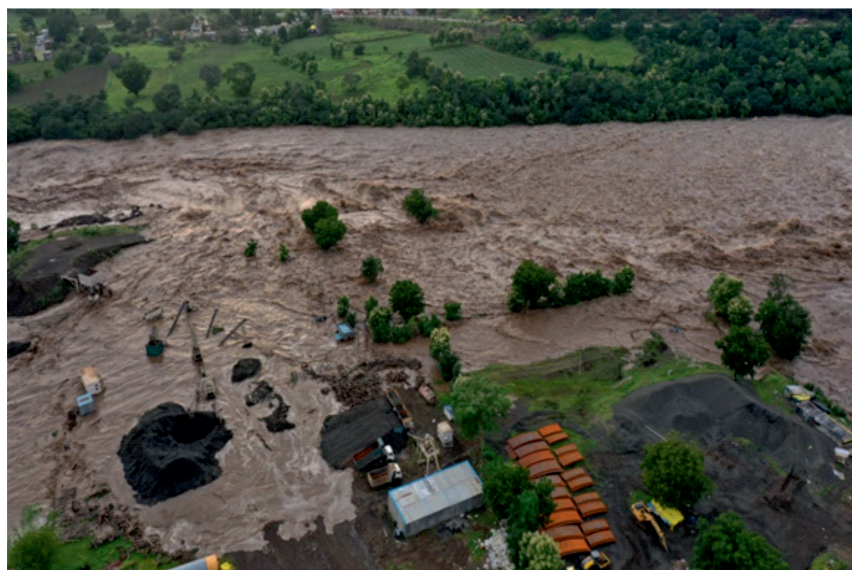
*Figure 2-30 : The submerged camp site at dam due to the water*

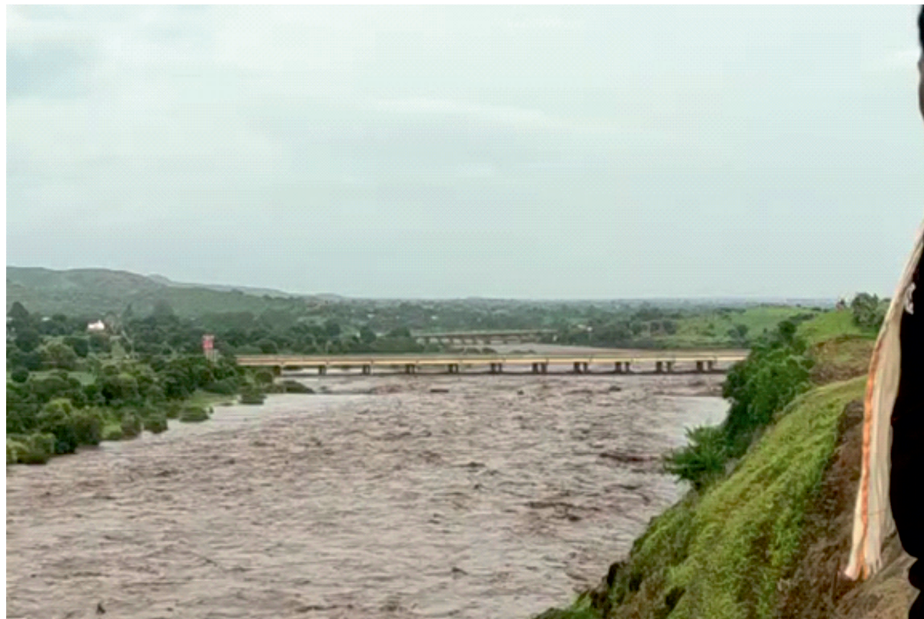
*Figure 2-31 : Water discharge in river (almost touching AB-NH bridge)*

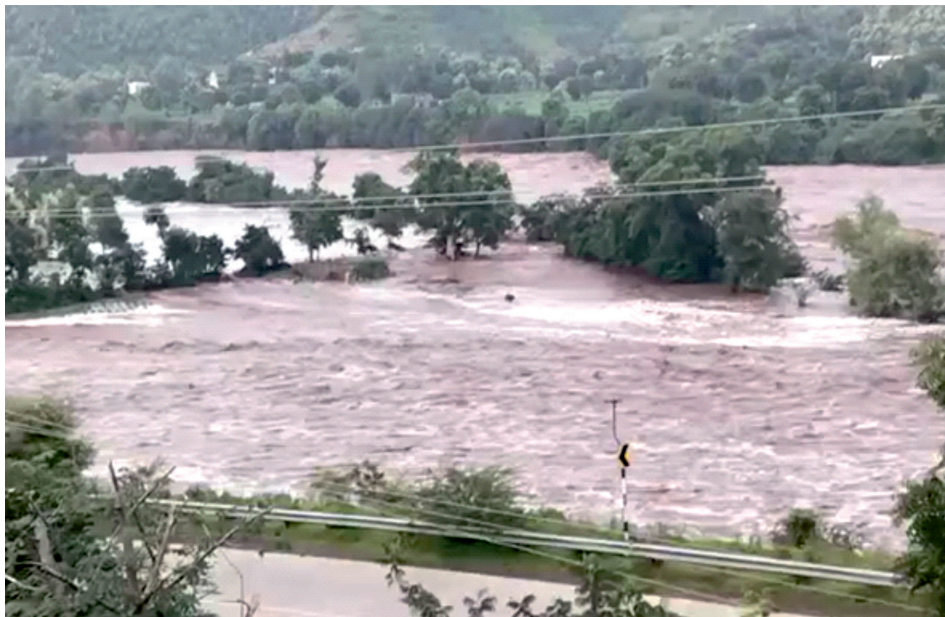
*Figure 2-32 : Water discharge in river at peak flow*

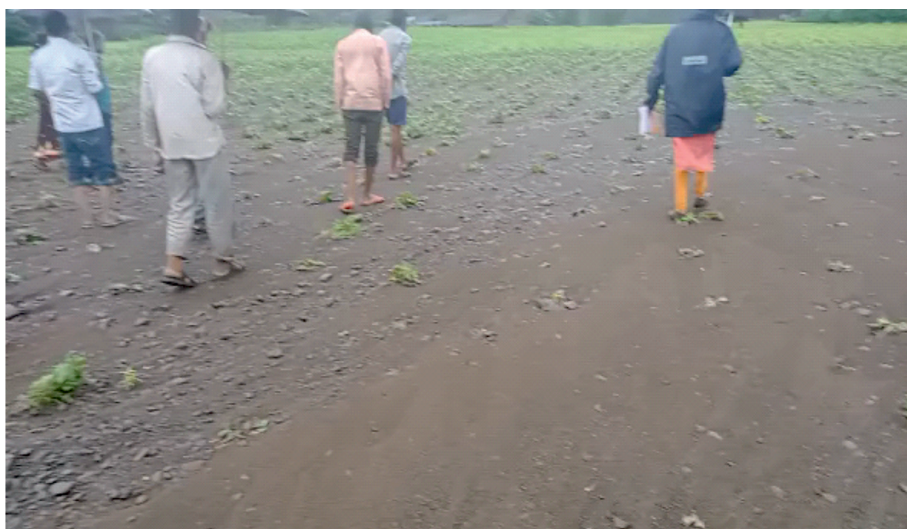
*Figure 4-2 : Deposit of sediment in farms adjacent to riverbank*

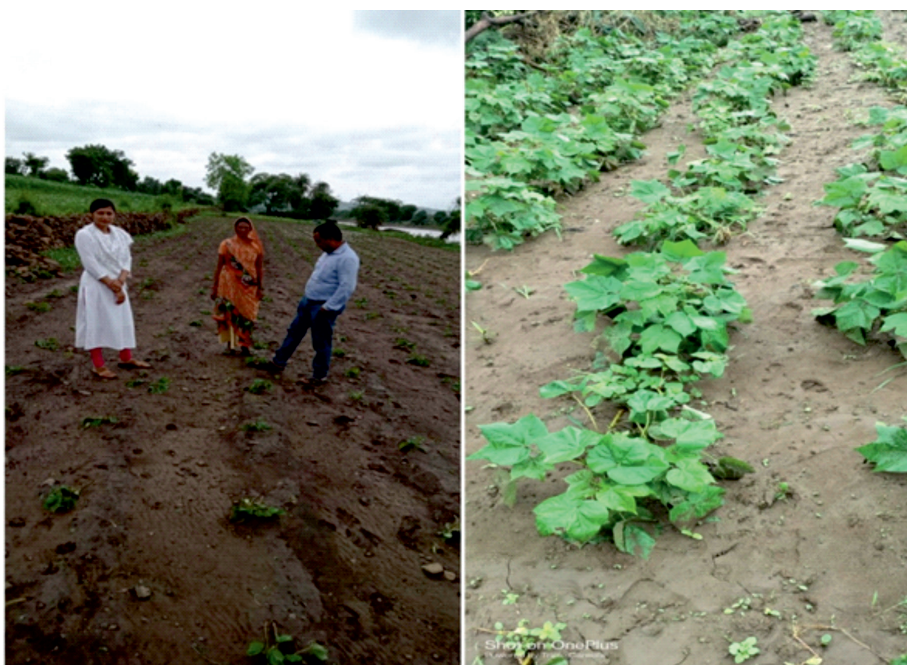
*Figure 4-3 : Sedimentation at farms in Simrali*

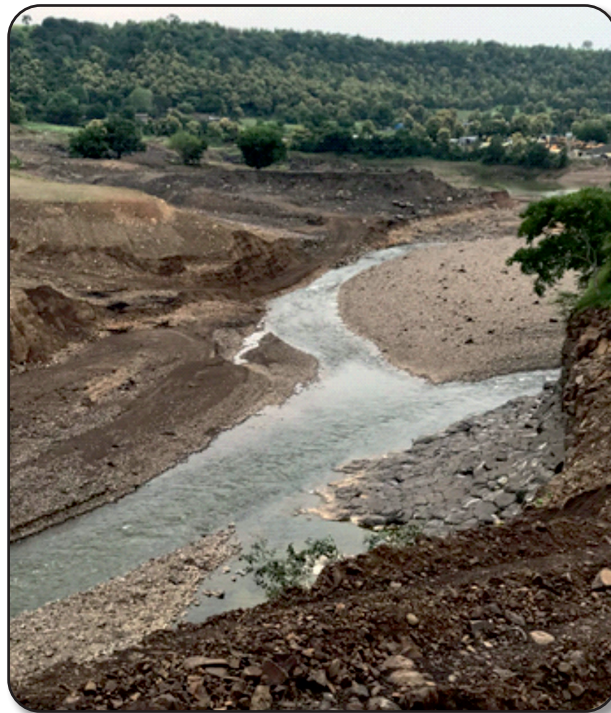
*Photo-9 : Dam condition after Breach*

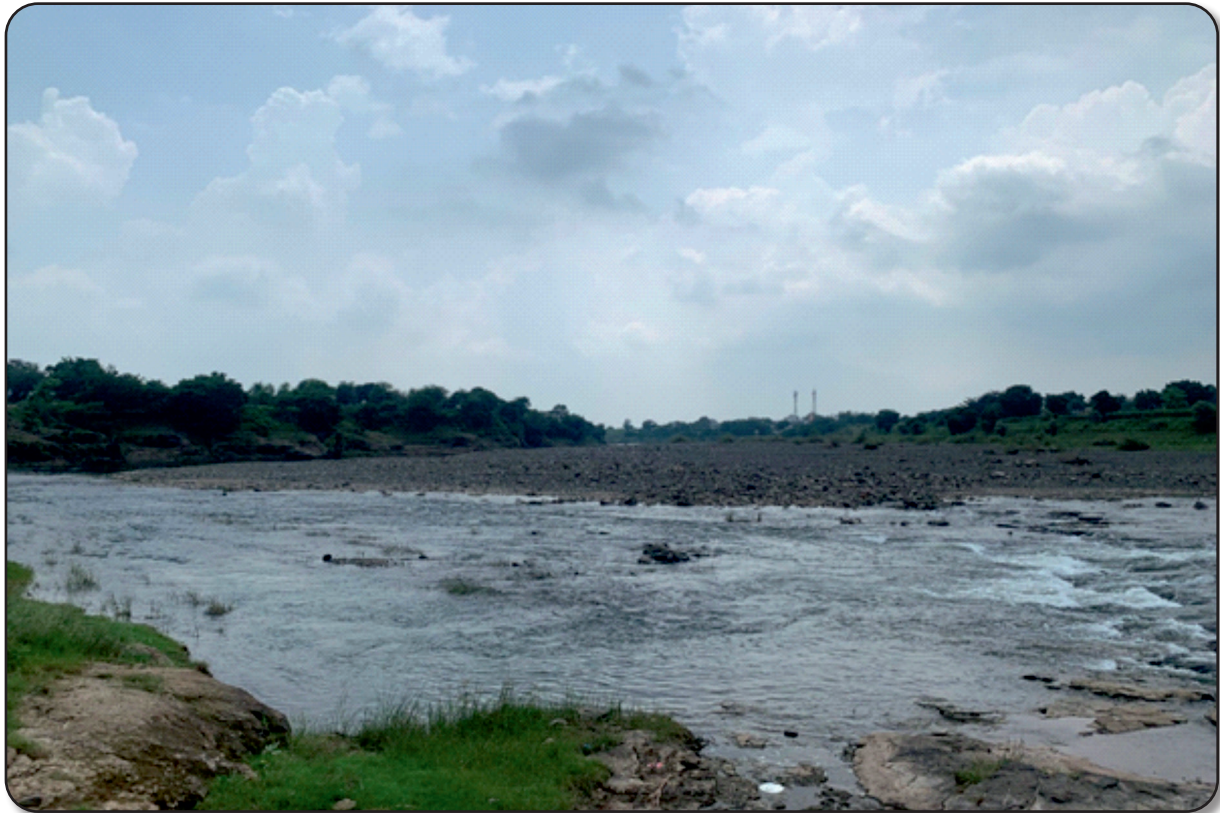
*Photo-10 : Downstream situation after breach*

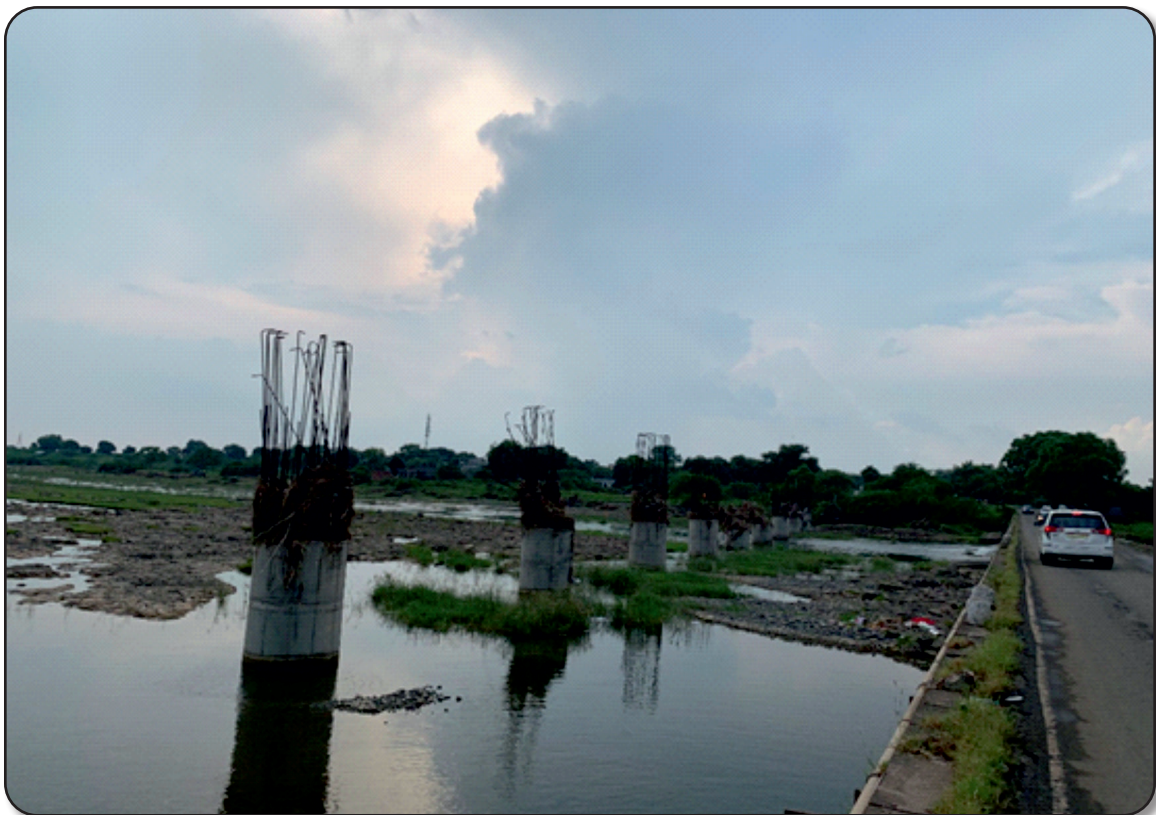
*Photo-11 : Flow water level indication Marks at Dahiwar*
