**A PRESENTATION ON THE SLOPE STABILITY STUDY  
AROUND SERCHHIP HMAR VENG, DISTRICT  
SERCHHIP, MIZORAM**

by  
**R.N. GHOSH,**  
Director

**Northwest-Southeast trending  
hillslope near Serchhip market;  
150 km South of Aizawl, District  
Serchhip, Mizoram.**

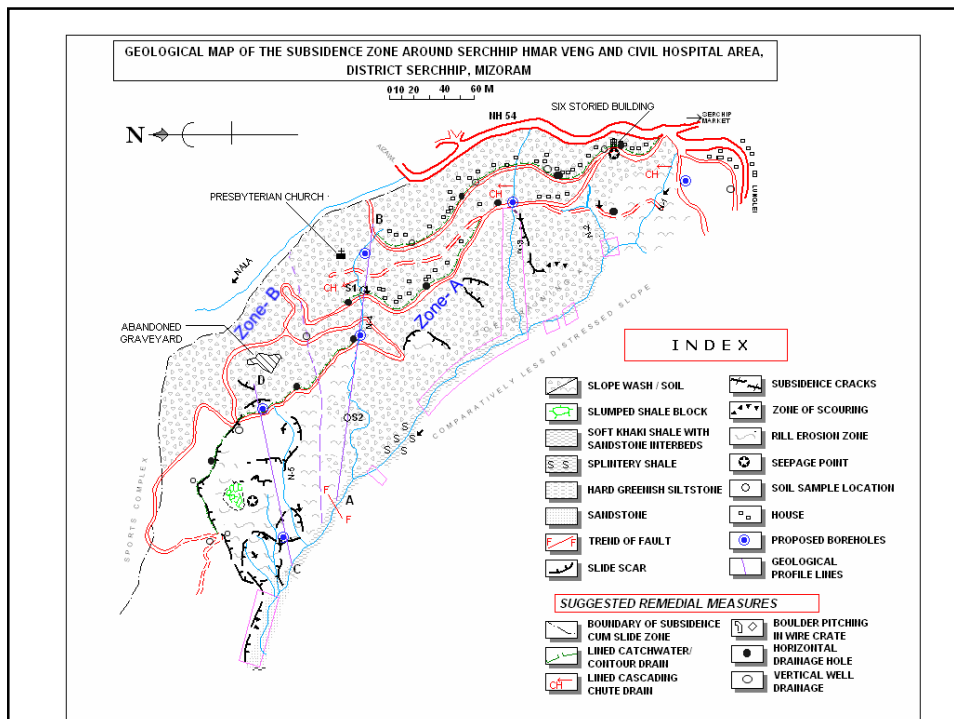
- Thickly populated hillslope (900 m X 300 m X 178m) affected by landslides and subsidences

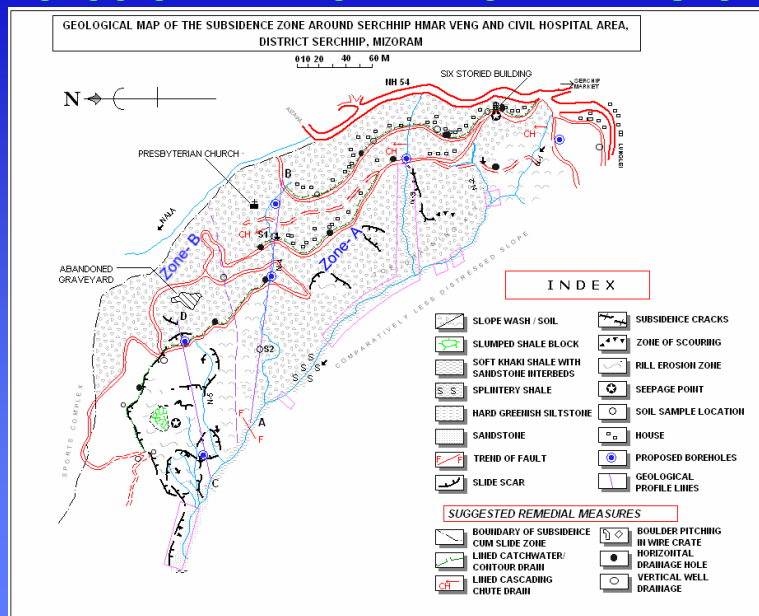
## GEOLOGICAL MAP OF AFFECTED HILLSLOPE

•Tightly folded soft, fragile, shale and sandstone interbeds of Middle Bhuban Formation of Bhuban Subgroup of Surma Group ( Tertiary). Affected by a few normal faults.

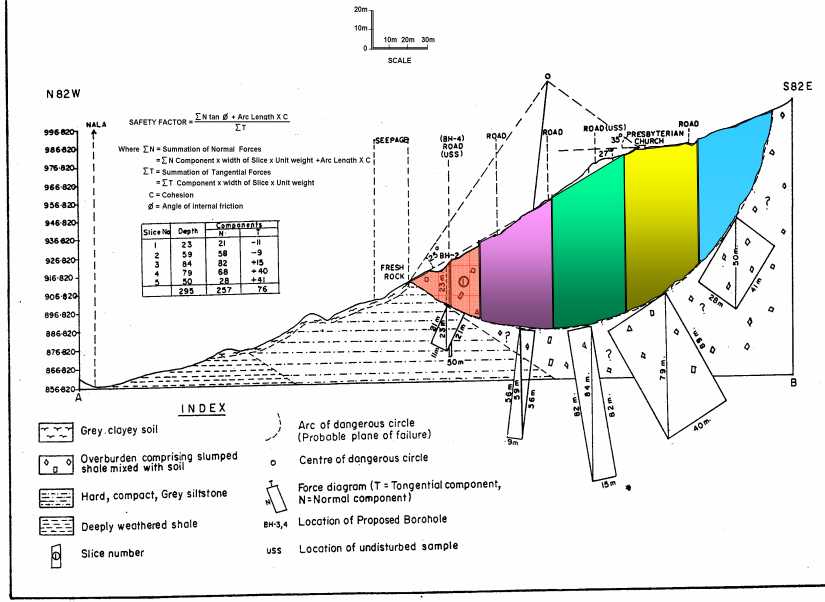
## STABILITY ANALYSIS OF THE HILL SLOPE ALONG GEOLOGICAL PROFILE LINE A-B, ZONE-A

1. Safety factor in natural moisture content = 0.828 (C=0.35 kg/cm<sup>2</sup>,  $\phi=11^\circ$ , unit weight=1.77 gms/c.c).
2. Safety factor determined in almost saturated condition = 0.493 (C=0.05 kg/cm<sup>2</sup>,  $\phi=8^\circ$ , unit weight=2.33 gms/c.c)

**Inference:** Safety factor falls conspicuously with gradual saturation (so also shear strength of the slope forming material). The slope is unsafe. Earthquake tremor accompanied by heavy rainfall may trigger slope failure.

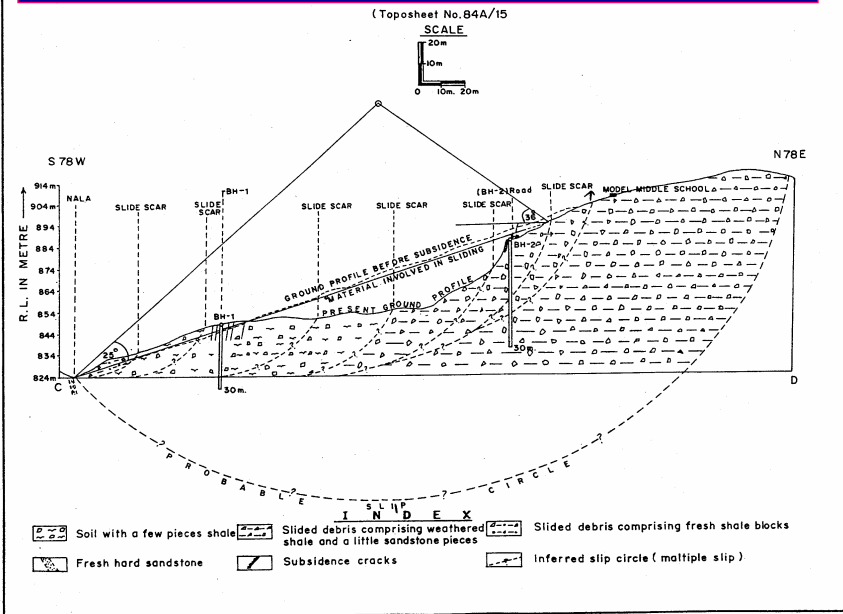
## GEOLOGICAL PROFILE ALONG LINE C-D, ZONE-B

- **Zone-B** (Sparsely populated northwestern part of the hillslope)
  1. A conspicuous slide (200m X180m) with numerous minor slides; appears to be multiple rotational slips
  2. Subsidence cracks on road benches at different levels
  3. Toe erosion of the hillslope along the northwesterly flowing nala.
