Lessons from 1st May 2013 Doda (India) Earthquake Reiterate Urgent Need to Mitigate Seismic Risk

– C.V.R. Murty¹, Ajay Chourasia², Hari Kumar³,
Anup Karanth⁴ and Pradeep Kumar R.⁵

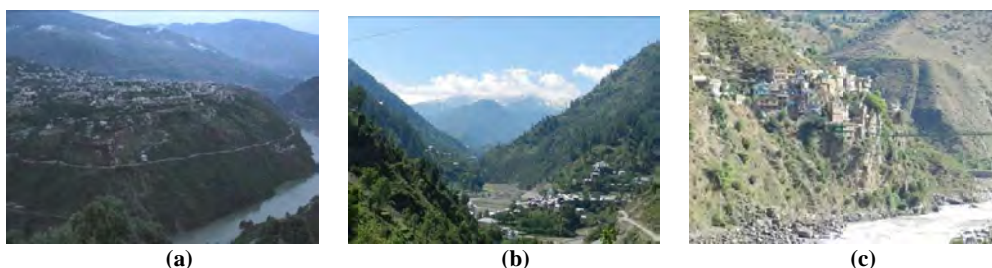
The landscape of Doda town shows settlements on both hill slopes and river terraces (Figure 3) and this is typical of most of the other towns nearby (like Gandoh and Premnagar). These hill slopes and river terraces are composed of heterogeneous materials – highly weathered sandstone rock, some granite outcrops, rounded to angular but smooth river boulders, cobbles, gravel, sand, silt, clay and other suspended matters that have been collected over centuries in the river terraces and hill slopes. For this reason, the ground shaking is not necessarily uniform all through the affected area. Another prominent feature of development in the area is the same construction types is followed in the valley as well as on the steep hill slopes. In general, houses built along the rim of river terraces have showed signs of settlement, while houses on the flat land seemingly had no such foundation damage; and houses founded on soft soils in towns of valley areas (like Kishtwar town), vertical cracks were visible in foundation arising from the soil.

Figure 3: Ariel views showing dense development on hill slopes/river terraces
(a) Doda (b) Gandoh (c) Premnagar town

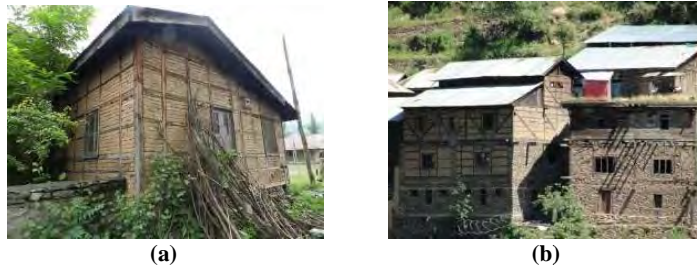
Figure 4: Variant of Dhajji-Dewari Houses: (a) without diagonal wood members, and (b) with no Dhajji (wood frame) in the ground storey

This is a housing typology with excellent earthquake-resistant features in which the traditional wisdom has been embedded gradually over centuries as earthquake disasters have been perennial concern for people living in the Himalayan region. The well built Dhajji-Dewari construction performed exceptionally well during the earthquake. But, over time, the traditional knowledge may not be completely efficient, when the modern construction has become an aspiration of the larger populace. Seismic deficiencies, identified in the recent editions of this typology, include large openings; large size rooms; tall storey; poor connections between foundation and walls, wall to wall and walls-to roof; absence of continuous plinth, sill and lintel bands; loosely packed infill masonry; low strength mud mortar, and heavy roof.

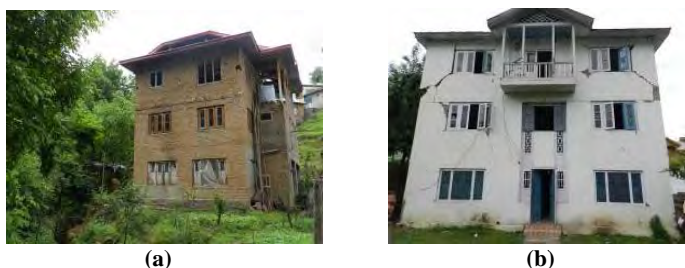
Figure 5: Brick masonry houses: (a) houses with RC floors did better even though they had no earthquake-resistant features like horizontal bands, and (b) houses with heavy wood floors did poorly; the walls dilated outwards in both plan directions and reduced the bearing of wood floors on the walls

Such houses are regular in plan constructed using poor strength of brick units with excessive mica content. Majority of construction are in mud mortar and with limited cement mortar of mix variation between 1:6 and 1:8 (by volume). In general, prominent deficiencies observed include (a) absence of horizontal bands and vertical reinforcing elements at wall corners; (b) absence of gable bands; (c) dilation of masonry walls at top floor due to lack of eaves band on which the roof is rested; (d) use of plain mud mortar in walls; (e) lack of complete roof truss; (f) excessively large opening in walls; (g) lack of reinforcement around door and window openings; (h) use of very heavy floors/roofs; (i) direct bearing of roof truss on the masonry walls, not adequately anchored into walls; (j) weak masonry courses – all headers in one course, all stretchers in the other, resulting in joints not being staggered; and (k) outward bulging of walls at floor levels due to heavy wooden floors.

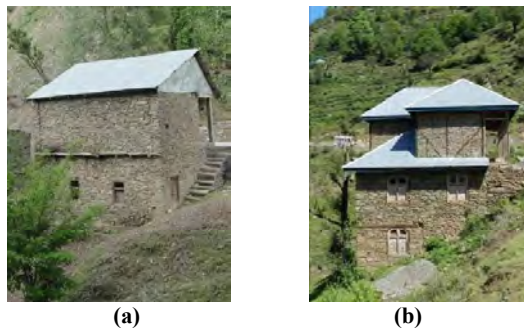
Figure 6: (a) Two-storey stone masonry house with basic earthquake-resistant features of seismic bands MISSING, and (b) Two-storey stone hybrid masonry house (with Dhajji-Dewari system adopted in upper elevations) but no earthquake-resistant features in lower storeys

This housing typology has good architectural design from earthquake safety point of view, but poor structural characteristics. The limited negative architectural features include adjacency and pounding; re-entrant corner; and mismatch of floor and roof levels. The main structural deficiencies include: (a) no use of through-stones leading to independent two leafs of stone masonry walls; (b) Inadequate or no connectivity of two perpendicular walls at intersections; (c) stone masonry is not dressed, but outside surface is ensured to be plumb; half dressed stones with pyramidal shape are prone to rotating outwards; (d) no bands are at any level; cut lintels in wood are used over openings

in walls; (e) weak mortar mix; (f) large mass, especially concentration of large mass at roof level of the building when heavy slate roofs are employed; and (g) poor connections between foundation-and-wall, wall-and-wall and wall-and-roof.

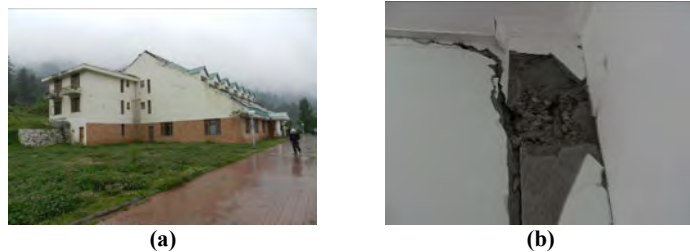
indiscriminate use of unsupported partition walls leading to inadequate load path. Only a few buildings such as government, academic institution buildings may be categorised as engineered ones, *i.e.*, designed and constructed using prevalent codes and practices. The typical damage sustained by these RC buildings includes frame-infill separation, spalling of concrete at the top of the column (where concreting is poorly done and reinforcement detailing is such that there is extreme congestion of steel reinforcement) and cracking/falling of bathroom tiles, as observed in the yet-to-be commissioned Tourism Department Building (Figure 7). Similarly, damages are noticed in the newly constructed Sub-District Hospital buildings in Badarwah.

Figure 7: (a) TRC building in Badarwah, (b) damage to column tops showing poor concrete and reinforcement detailing

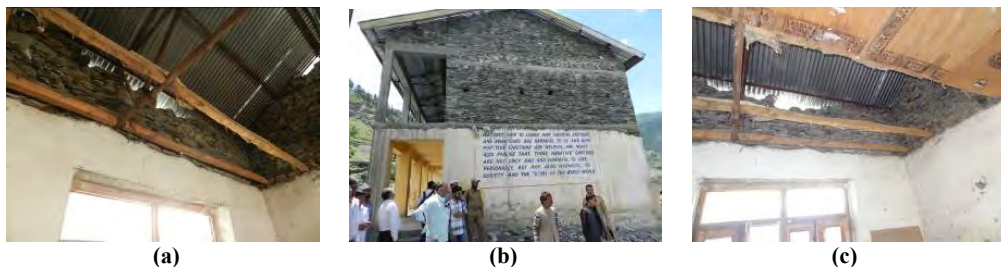
Figure 8: (a) Informal trusses rested directly on stone walls without any wall plates (at Gandoh), and (b) large stone gables not provided with gable bands and gable end trusses are not complete with bottom chord and vertical posts (at Bhalessa), and (c) falling of false ceiling due to poor anchorage

The injuries in these schools were also reported due to collapse of stone masonry gable wall, separation of walls at junctions, separation of wythes of walls, and falling of false ceiling due to poor anchorage (Figure 8).

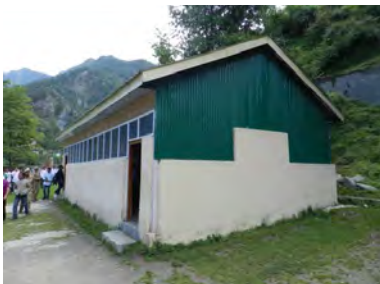
Figure 9: Wood frame single-storey school construction with brick masonry up to sill level and light roof

But, there are also good examples of school buildings constructed using traditional constructions, in conformance with seismic resistant features; which can act as role-model for replication in future constructions (Figure 9).

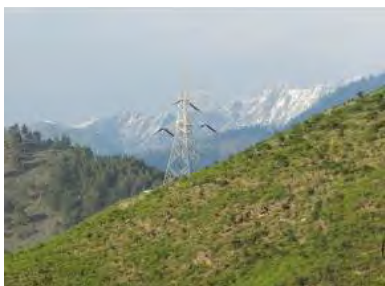
Figure 10: Transmission towers running across Doda and Kishtwar districts pass through difficult terrains: (a) soft soils, and (b) adjoining vertical cuts made for roads

The 132-KW high voltage transmission line of National Hydroelectric Power Corporation (NHPC) serves the districts of Doda and Kishtwar of J&K state. As such there was no loss in power transmission during or the aftermath of the earthquake, because there was no surface rupture due to the earthquake, which is normally expected in earthquakes with higher intensity of shaking. However, these transmission lines are founded on soft soil adjacent vertical cuts (Figure 10), which are vulnerable and may cause secondary hazard.

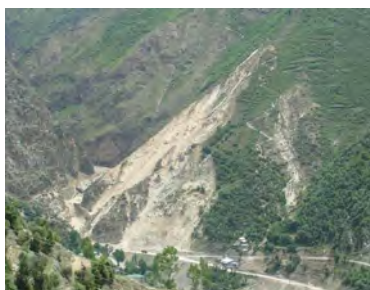
Figure 11: Earthquake-induced landslide at Shalimar (Kishtwar) on National Highway

Roads are the only modes of transportation system constructed by freshly cut on the hill slopes, causing four earthquake induced massive landslides (Figure 11) in the region. These landslides are attributed to the geology and intense rainfall in the area. Further, the human intervention such as cutting for roads and embankments, excavation for buildings etc., adds instability to slopes extensively.
