# Kinematic Analysis of Rainfall Induced Rock Slide Along Roadcut Slopes — A Case Study on Dhalli Landslide, Himalayan Region

C. Prakasam,\* Aravinth. R,\* Varinder S Kanwar\* and B. Nagarajan\*\*

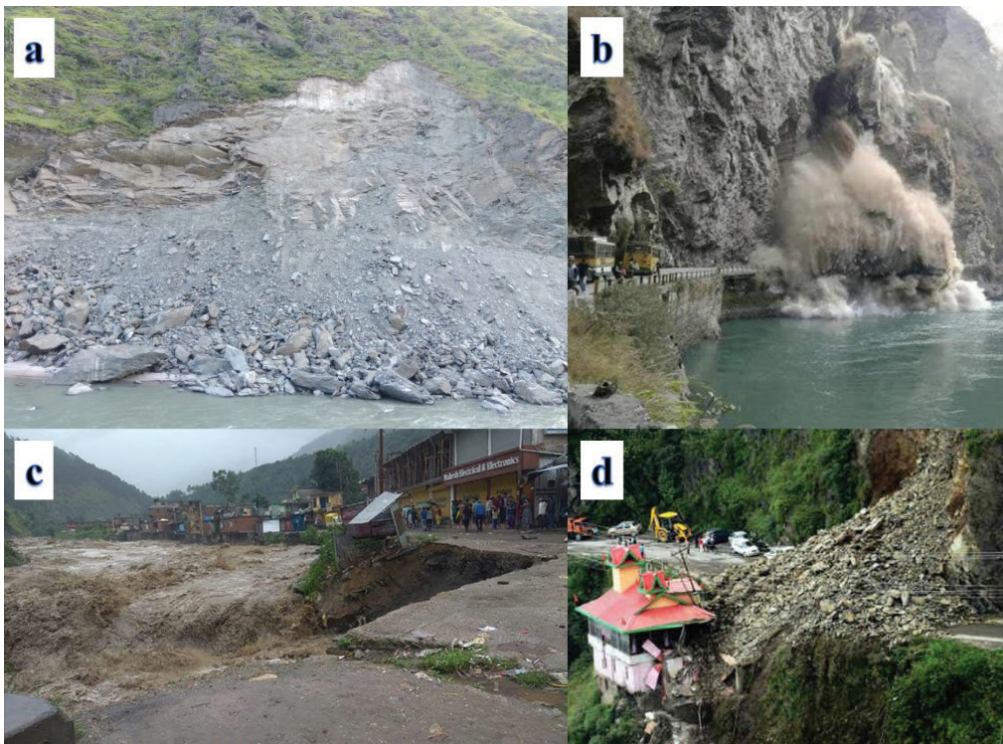
**Fig. 9.1: A section of Road has been washed away due to heavy downpour in Balichowki area, Mandi District (August 2019) source: Indiatoday, Landslide Along NH-21 (Chandigarh – Manali), December 2015. source: Indiatoday**

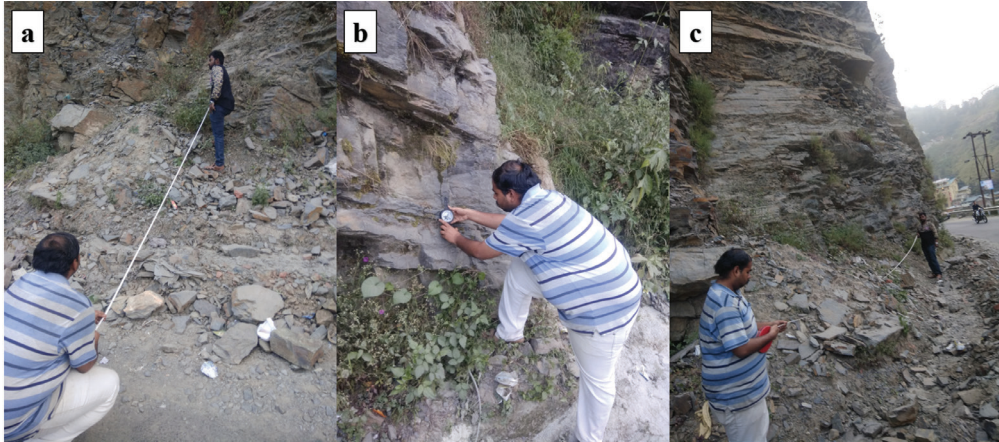
**Fig. 9.4: Collection of various joint sets from Study Area**

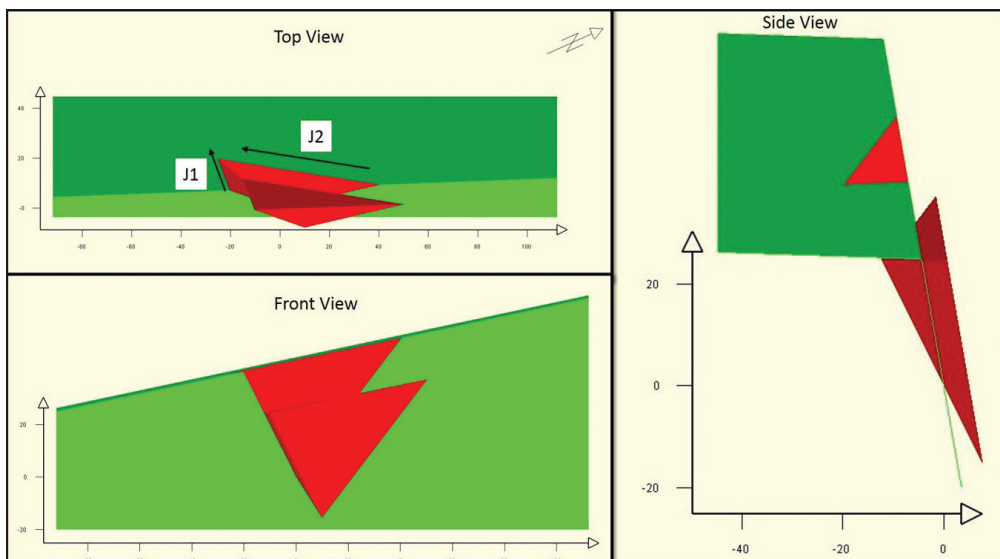
Fig. 9.9: Top, Front and Side view of the Dhalli Rockslide

Based on the results computed the total wedge area of the joint 1 is 297.33 sq. mts and wedge area for the joint 2 is 1587.52 sq. mts. The total factor of safety of this critical slope is derived as 0.9 which is below required value.
