# Documentation on Dam Leakage, Breaching and Disaster Management at Karam Dam, Madhya Pradesh

**National Institute of Disaster Management**

Ministry of Home Affairs, Government of India

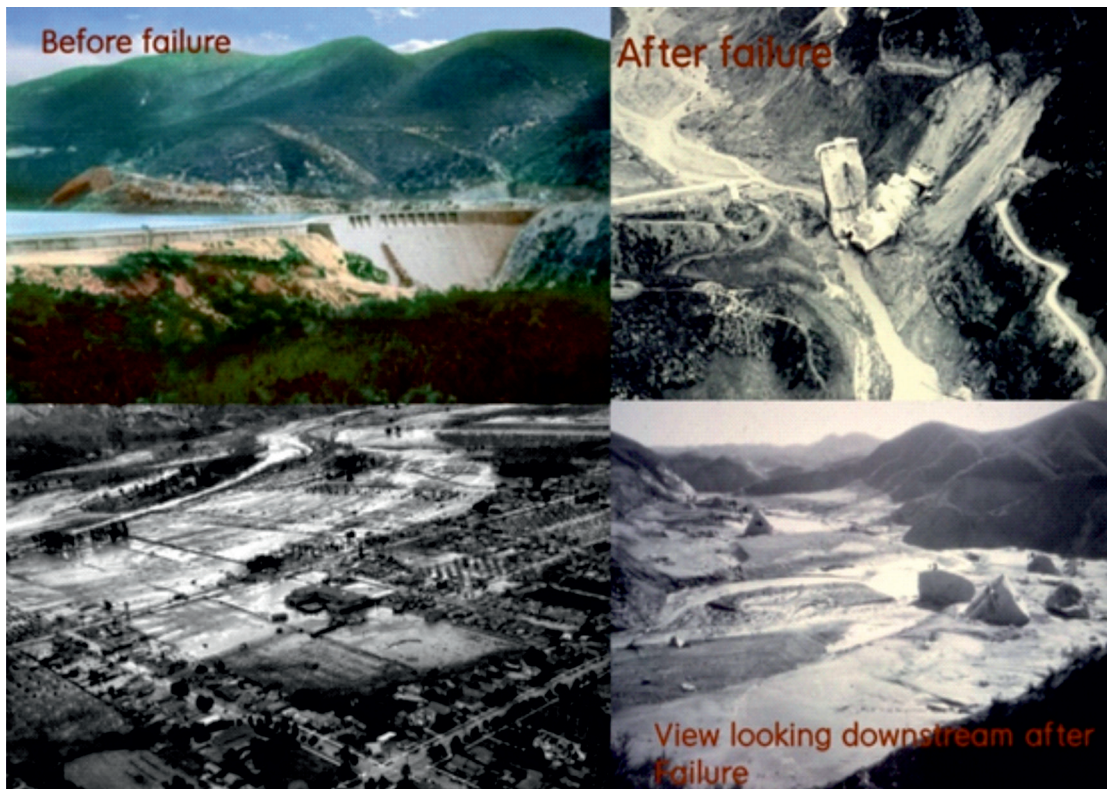
Eventually, it was concluded that the failure was entirely due to the geology of the site. The site location of St. Francis Dam was unsuitable for a concrete gravity dam. The varying geology between the two canyon walls and the inconsistent and instability features of the rock slopes were unacceptable for a dam foundation.

Not only the geology of the site was in question, but also the design and construction techniques were questionable. The failure to incorporate essential dam safety features into the design had resulted in the collapse. A lack of uplift relief and expansion joints, along with drastic modifications of the dam during the construction contributed to the collapse of St. Francis Dam. The failure of the dam caused a huge devastation in downstream resulted in flooding and submergence of downstream settlements as shown in the below Figure 1-6.

*Figure 1-6 : Losses due to failure St. Francis Dam (California, 1928)  
Source: J. David Rogers, 2013 AEG Shlemon Specialty Conference*

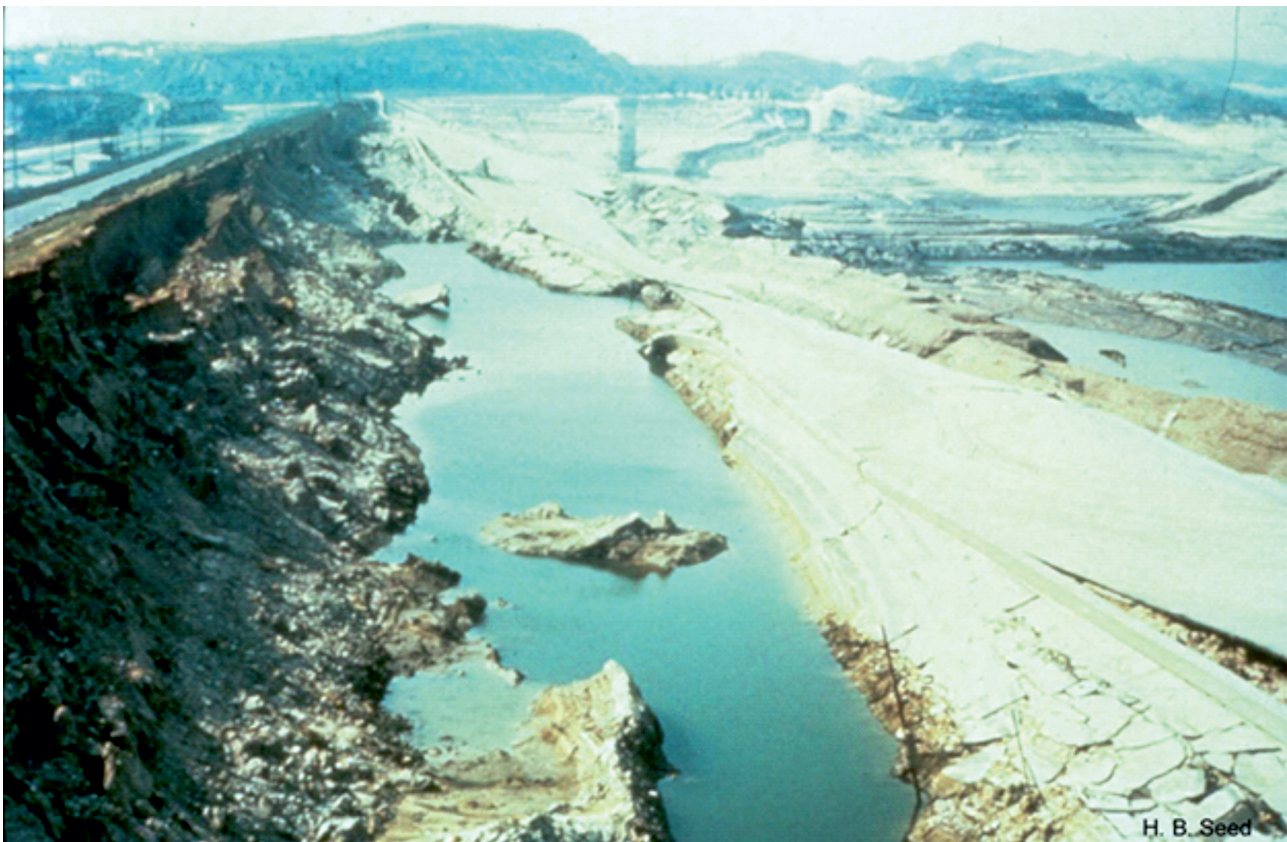
On 9<sup>th</sup> February 1971, the San Fernando earthquake occurred with an estimated magnitude of 6.6 on the Richter scale. At the time of the earthquake, the water level in the reservoir was about 11 m below the crest. This reduced level was due to an earlier seismic stability analysis that imposed a minimum operating freeboard criterion of 6 m. During and immediately after the earthquake, a major slide event involving the upstream slope and the upper part of the downstream slope occurred (Fig. 1-9). As a result of the slide, a freeboard of about 1.5 m remained.

Figure 1-9 : Upstream slope of the dam after earthquake and draining of lake; Tower No. 2 is in the background (standing).

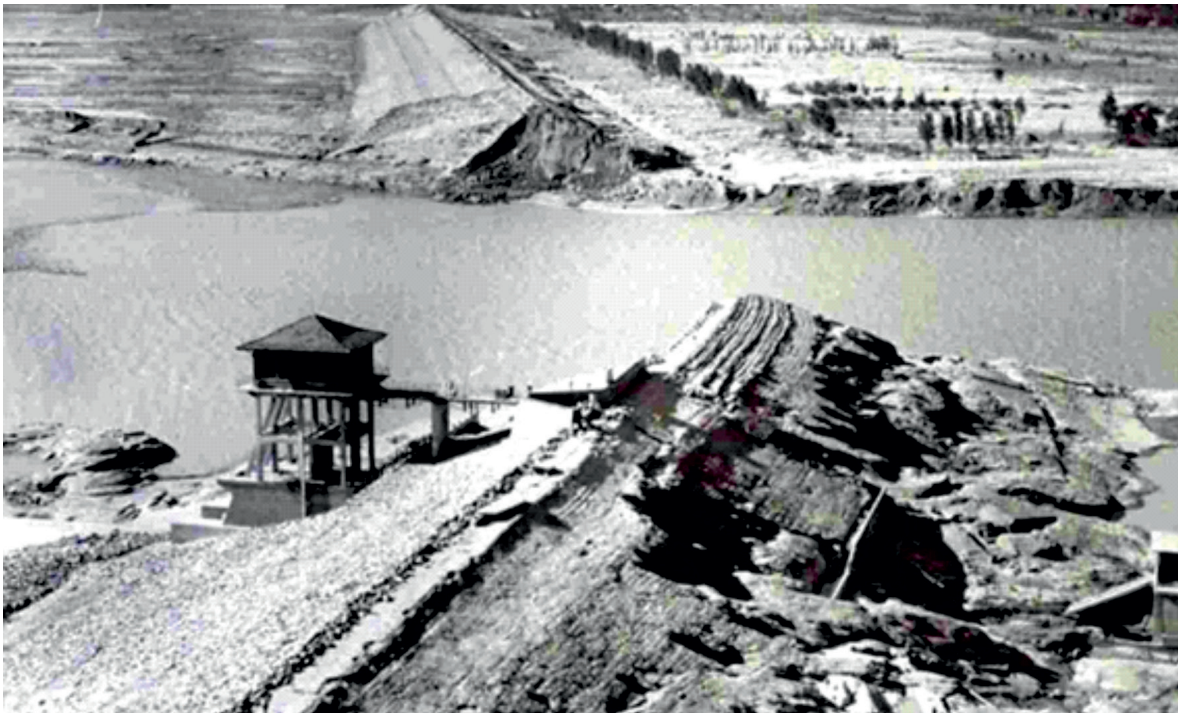
In August 1975, the region experienced an extreme flood, resulting in quantities of water falling that had not been considered during the construction of the dam. More than a year's worth of rain fell in only 24 hours, and the dam failed on the 8<sup>th</sup> August as shown in Figure 1-10. The breaching of the dam leads to the release of 700 million cubic meters of floodwater which caused flooding in the communities and homes downstream.

*Figure 1-10 : The Banqiao dam after failure*

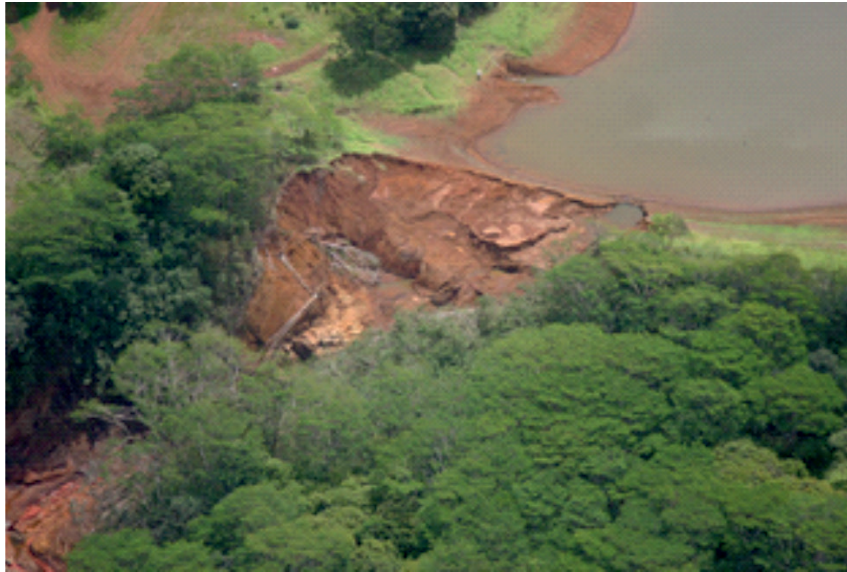
The devastating failure of the Kaloko Dam took place on 14<sup>th</sup> March 2006. More than 13.6 m<sup>3</sup> of water flowing furiously wiped out almost everything on its way sweeping away 7 people as well (Ancheta 2021 updated). **The dam failure was a result of unusually heavy rainfalls. The water flooded downhill through a ravine east of the town of Kilauea, Hawaii, being 20-70 feet high. Investigations brought out the possible reasons for failure as inadequate inspection of the dam and low maintenance as shown in Figure 1-12.**

Figure 1-12 : Kaloko dam failure

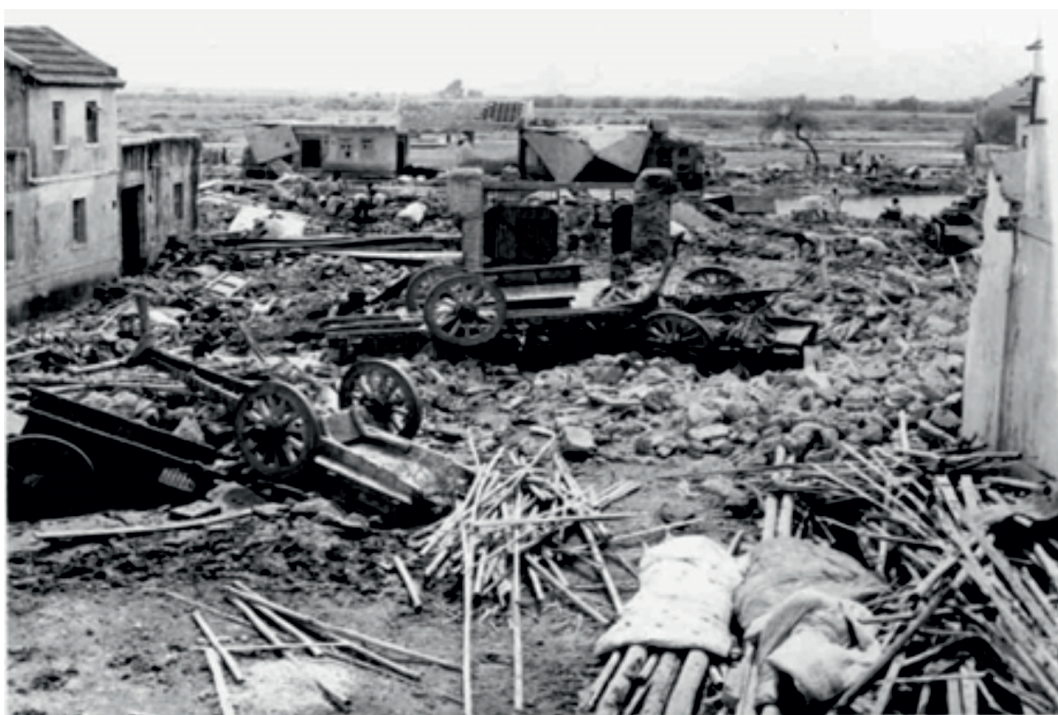
*Figure 1-13 : View of a destroyed part of Morbi after the Machchu dam failure*

The failure was caused by excessive rain and massive flooding leading to the disintegration of the earthen walls of the 4 km long Machchu dam. The actual observed flow following the intense rainfall reached 16,307 m<sup>3</sup>/s, thrice what the dam was designed for, resulting in its collapse. The 762 m of left and 365m of the right embankment of the dam were collapsed. Within 20 minutes, the floods of 3.7 to 9.1m height inundated the low-lying areas of Morbi industrial town located 5 km below the dam.

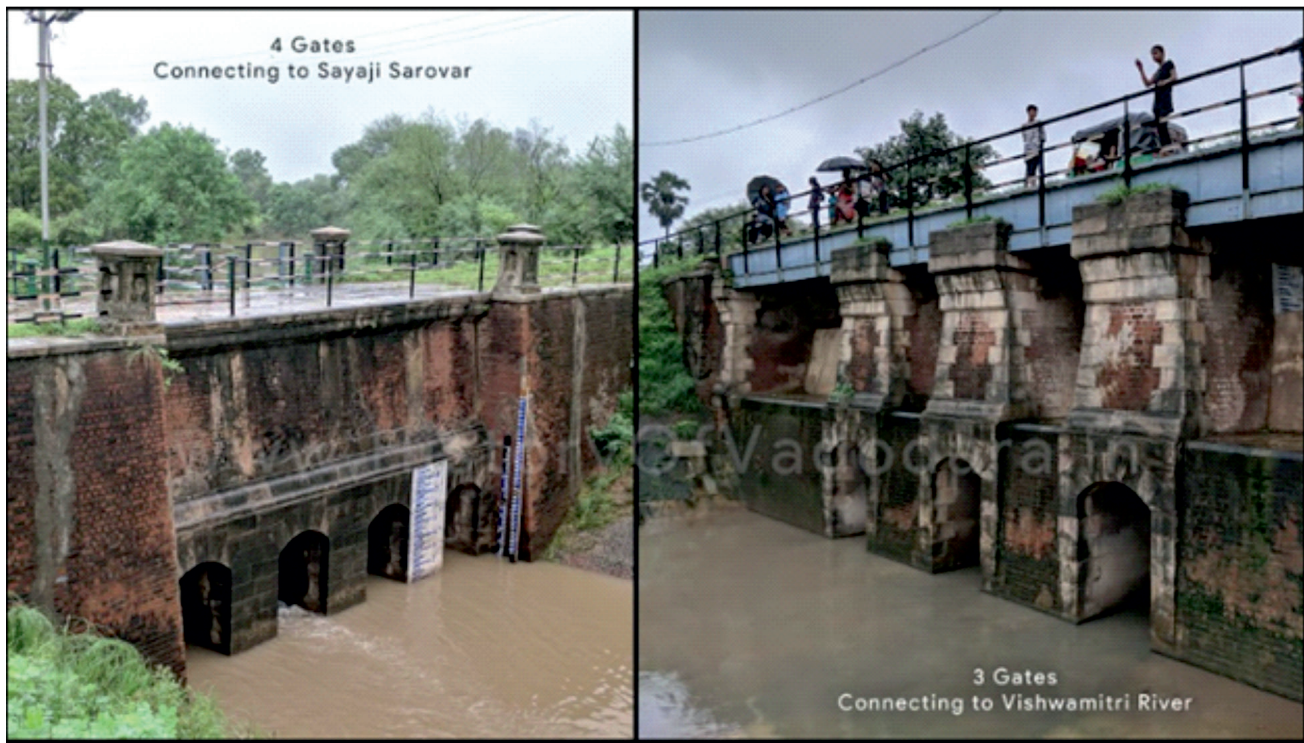
Figure 1-14 : The condition of Pratappura dam gates

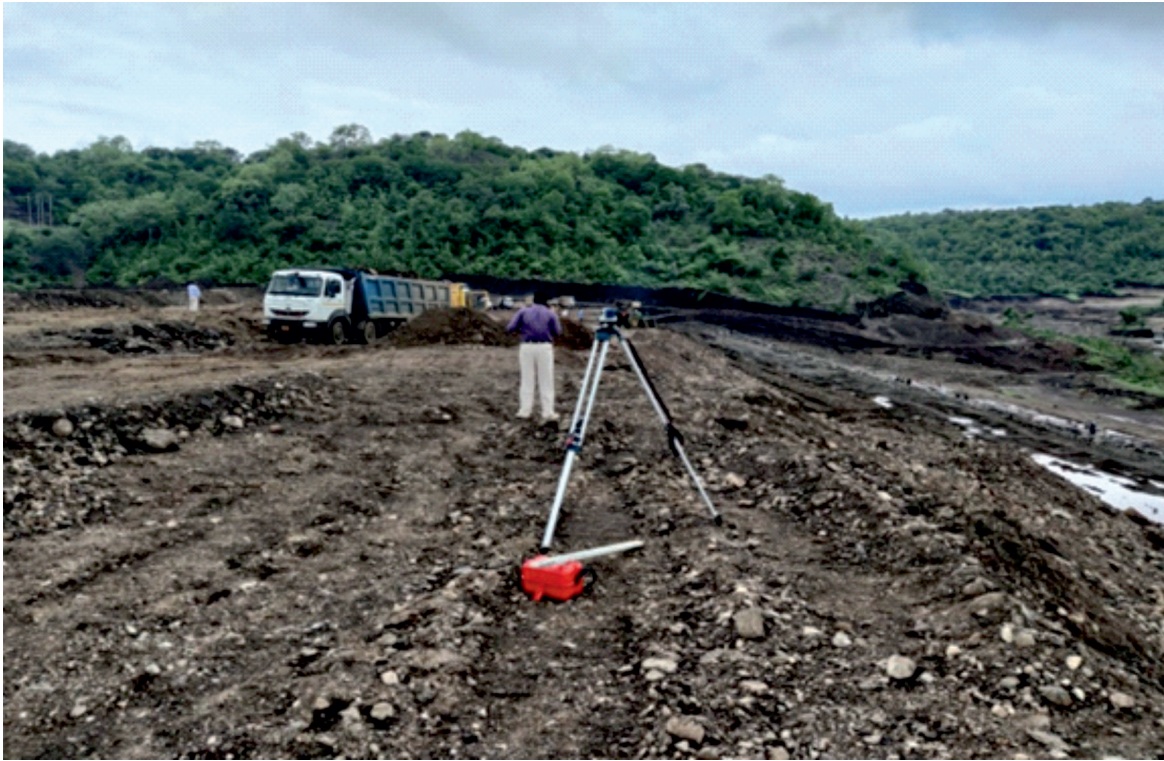
*Figure 1-19 : Earthen Portion of the dam during construction*

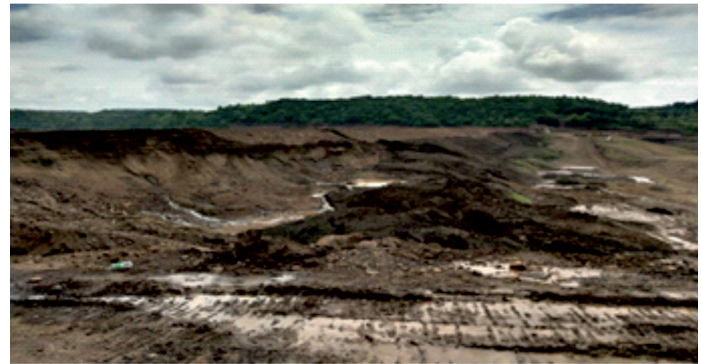
On 11<sup>th</sup> August 2022, the efforts made by the administration and technical teams to control the seepage succeeded and everyone felt that the situation was under control. On the early morning of 12<sup>th</sup> August 2022 around 7:30 AM, a large earthen portion of the dam bund of about 10 meters in height and 20 meters in length slides (Figs. 2-4 & 2-5) in the hearting zone (comprises black cotton soil) which again lead to a severe panic of a dam breach. District Magistrate and Superintendent of Police rushed to the dam site with their teams and appraised the incident to the hon'ble Chief minister (CM) and Chief Secretary (CS) of the state.

*Figure 2-5 : Dam site collapse of hearing scene  
at 11:00 AM on Day 1, 12<sup>th</sup> August*

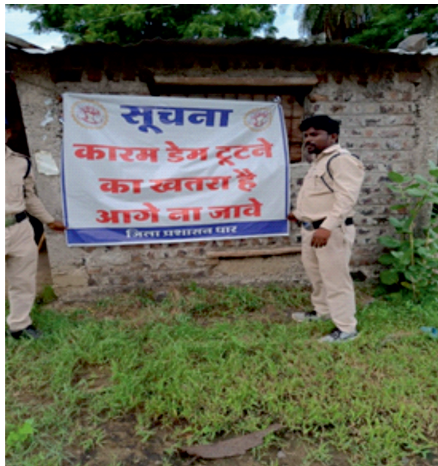
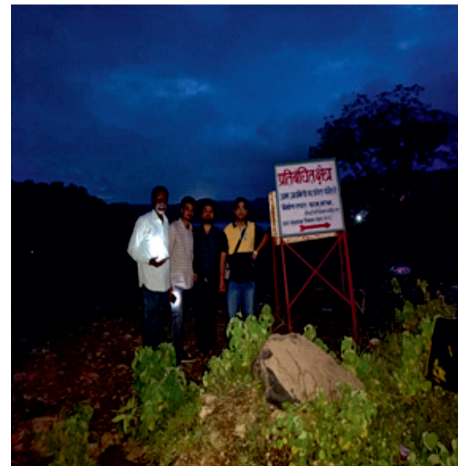
Figure 2-11 : Warning Signs in villages

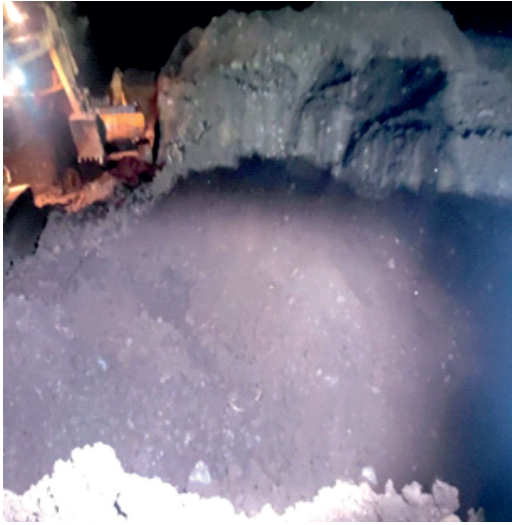
*Figure 2-12 : Cutting the hillock and creating the channel*

After working for more than 8 hours, by 2:00 AM on 13<sup>th</sup> August 2022 technical teams and their earth movers could create the originally planned channel by 50% but that brings down the level to 295.5 m from 296 m. By 4:00 AM, everyone on site realized a cut needed to be made on the dam structure to release water. At 4:30 AM, Additional Chief Secretary (ACS), Water Resources Department (WRD), and Commissioner Indore were briefed on the necessity of the planned cut to the dam structure (Fig. 2-14).

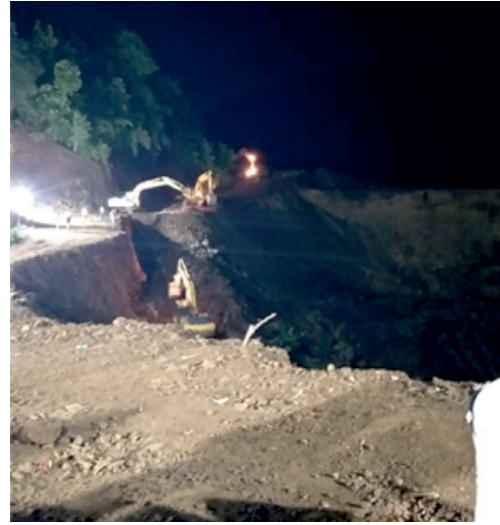
*Figure 2-13 : The continued Excavation efforts*

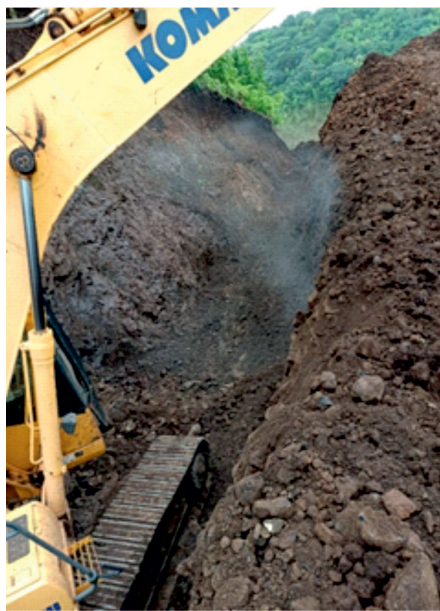
Figure 2-25 :  
Rising levels of  
uncertainty due to  
hard rock on 13<sup>th</sup>  
August, 2022

On the dam site, the CWC officials completed the inspection and they were surprised at the quality of construction. The CWC officials did the technical analysis of breaching the dam and put forth the pros and cons of breaching the dam. The same was briefed to the CM in live interaction between 5:15 PM to 6:15 PM. After several administrative discussions at the state level, Chief Sectary (CS) directed the field teams that the state has decided to breach the dams per technical advice. The technical team at the site started the creation of the channel by cutting the embankment within minutes (as shown in Fig. 2-25).

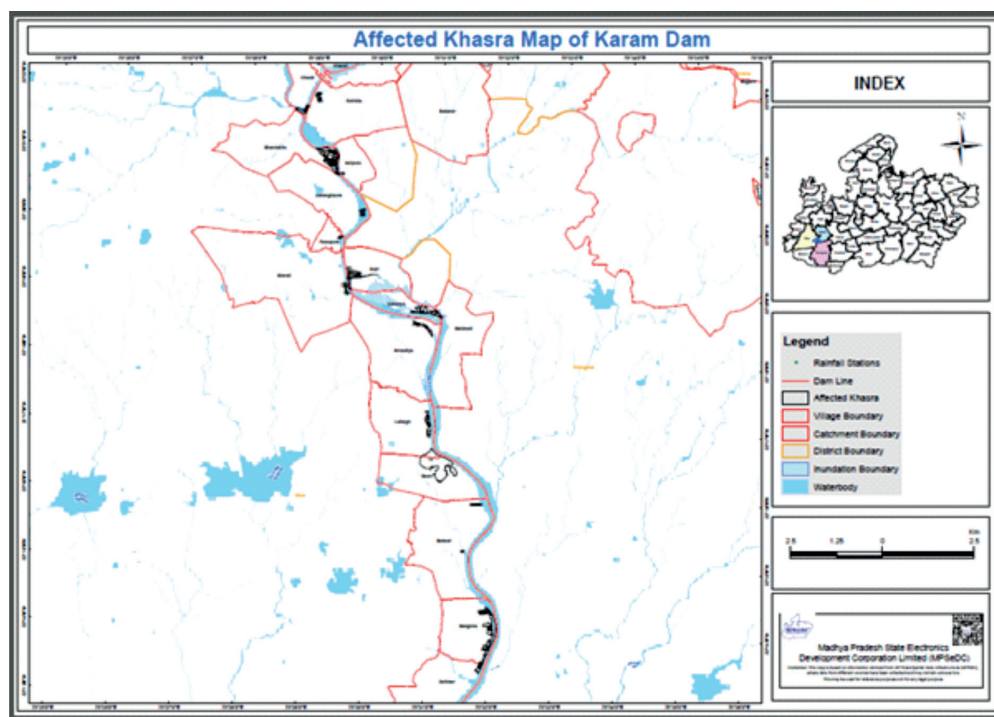
The peak discharge from the side channel created at the Karam dam site passed at around 5:30 PM. The flood wave inundated (low-intensity submergence) very few parcels (Tables 4.1 & 4.2). A small bridge in the village was found inundated. The flood level remained almost 2 ft. below the deck level of a bridge on Agra-Bombay Road.

Figure 4-1 : Affected parcels due to breaches of Karam dam.

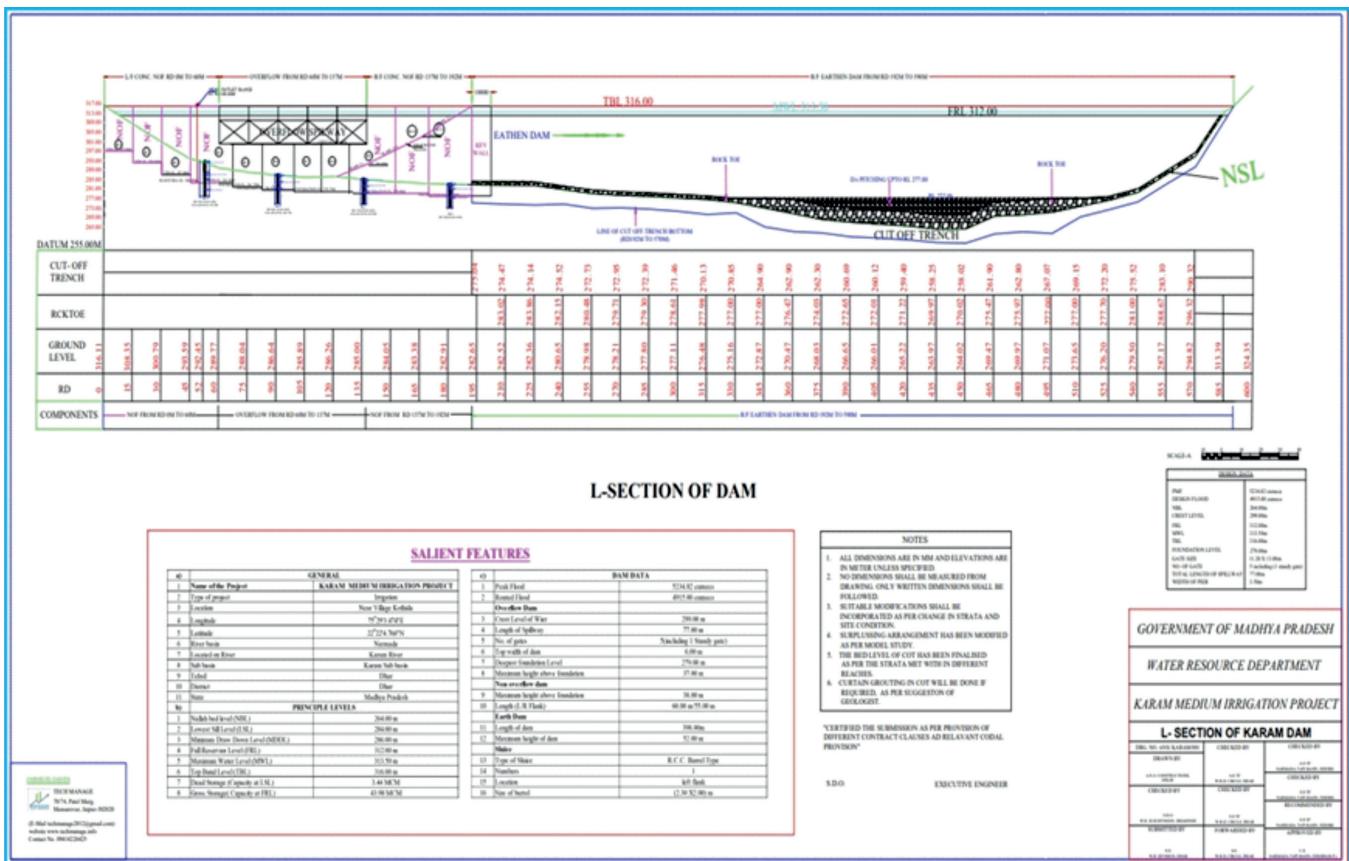
Longitudinal Section of the Dam

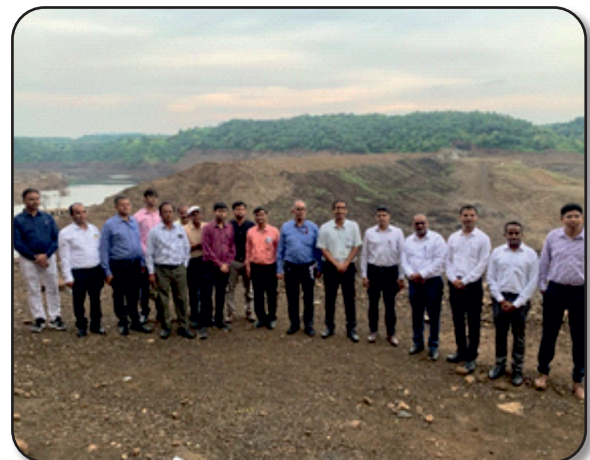
*Photo-4 : Visit to Dam site*

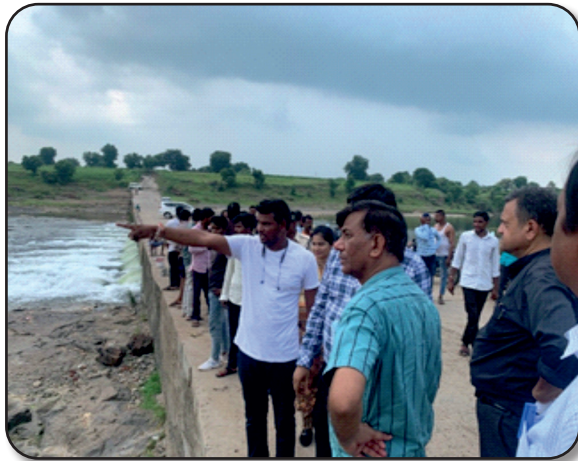
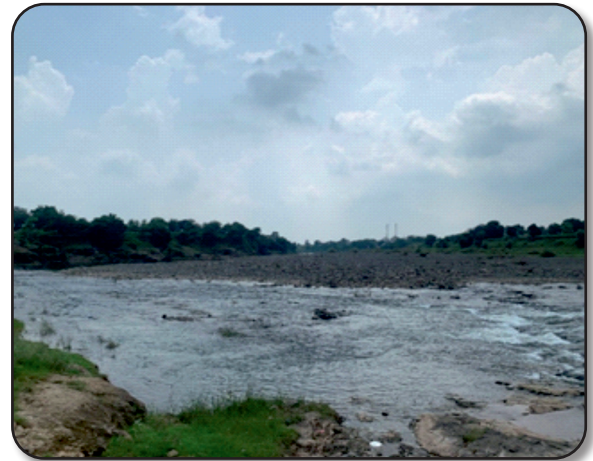
*Photo-8 : Visit to Downstream Villages*
