**A PRESENTATION ON THE SLOPE STABILITY STUDY  
AROUND SERCHHIP HMAR VENG, DISTRICT  
SERCHHIP, MIZORAM**

by  
**R.N. GHOSH,**  
Director

**Northwest-Southeast trending  
hillslope near Serchhip market;  
150 km South of Aizawl, District  
Serchhip, Mizoram.**

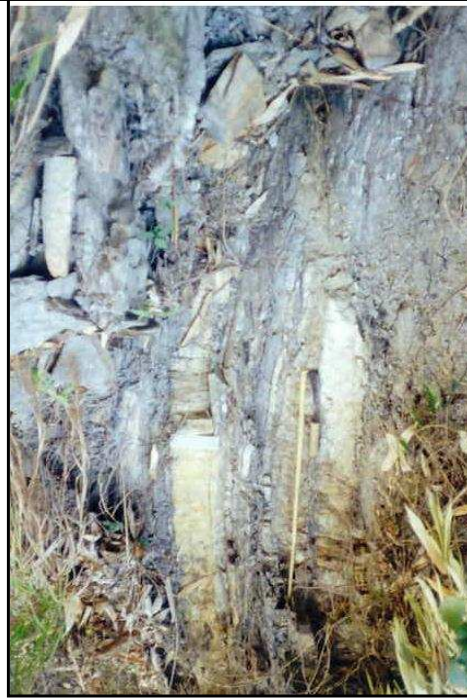
## GEOLOGICAL MAP OF AFFECTED HILLSLOPE

•Tightly folded soft, fragile, shale and sandstone interbeds of Middle Bhuban Formation of Bhuban Subgroup of Surma Group ( Tertiary). Affected by a few normal faults.
