Lessons from 1st May 2013 Doda (India) Earthquake Reiterate Urgent Need to Mitigate Seismic Risk

– C.V.R. Murty¹, Ajay Chourasia², Hari Kumar³,
Anup Karanth⁴ and Pradeep Kumar R.⁵

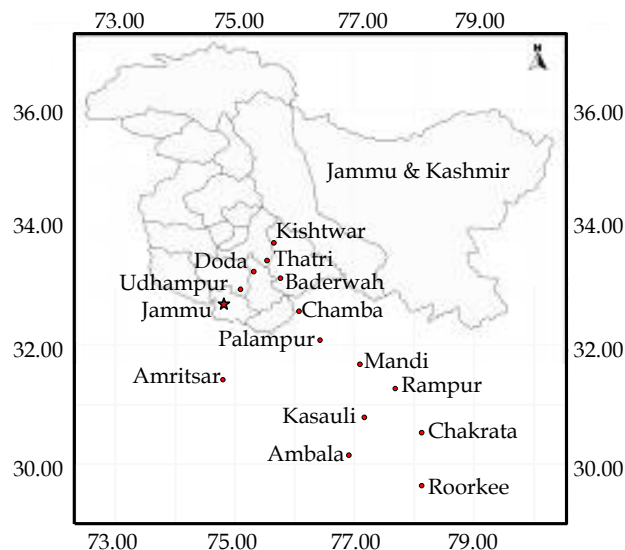
Figure 1: Location of 11 strong motion accelerograph stations operated by Department of Earthquake Engineering, IIT Roorkee, India around the area affected by the 01 May 2013 event

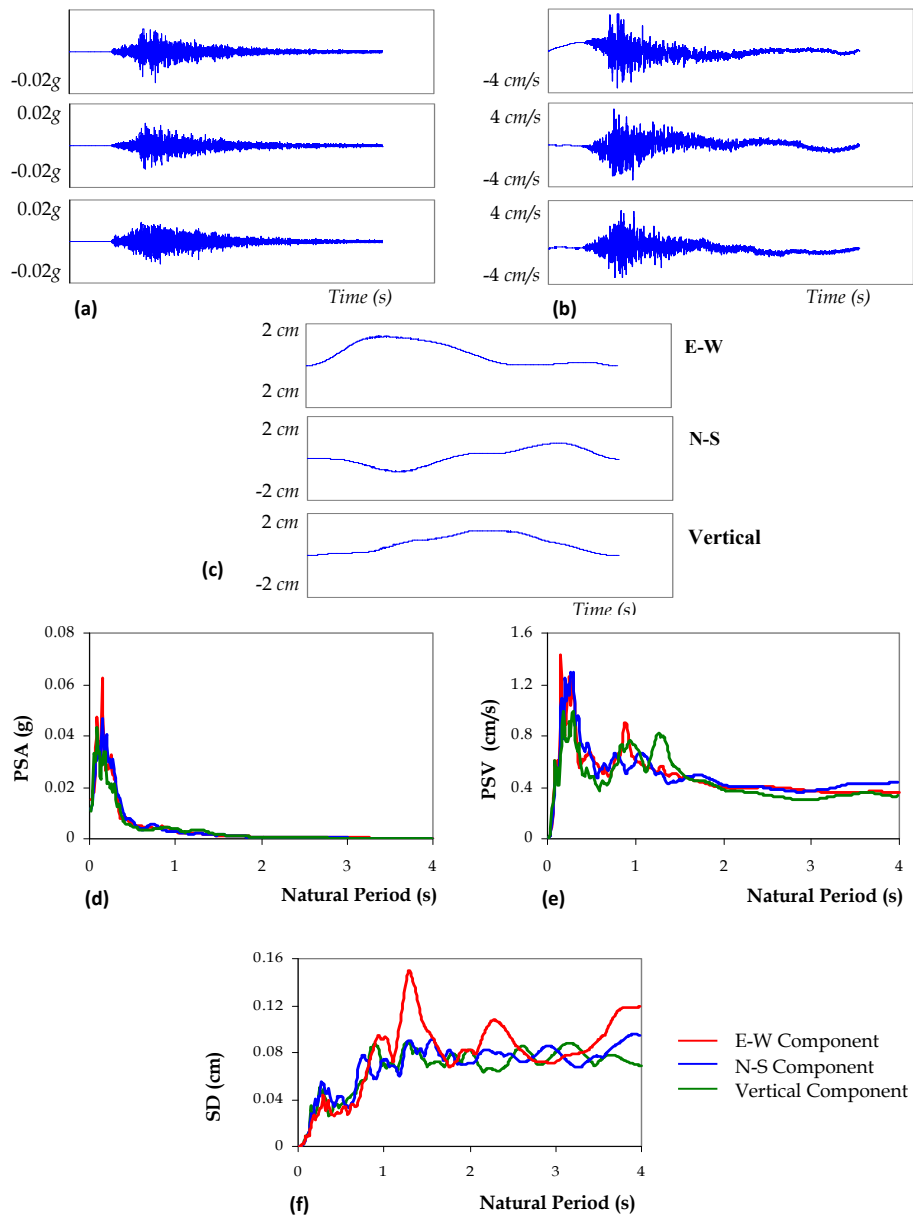
Figure 2: Ground Motion Time Histories at Chamba Station, closest to epicentral region (a) acceleration, (b) velocity, (c) displacement; and corresponding (d) pseudo-acceleration, (e) velocity and (f) displacement response spectra
